The trick was holding up the roof while leaving plenty of room to work

by Larry Buck

Replacing a Stone Foundation

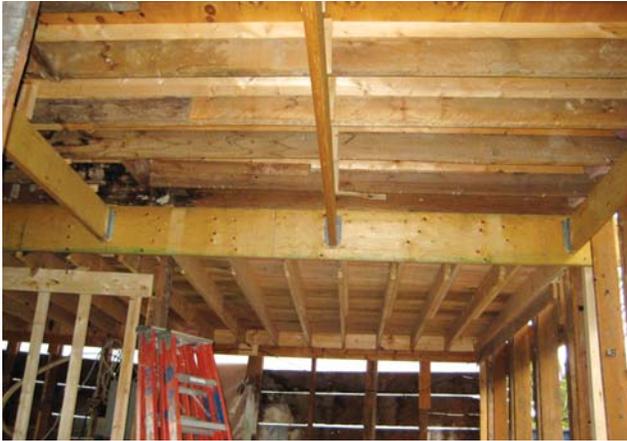
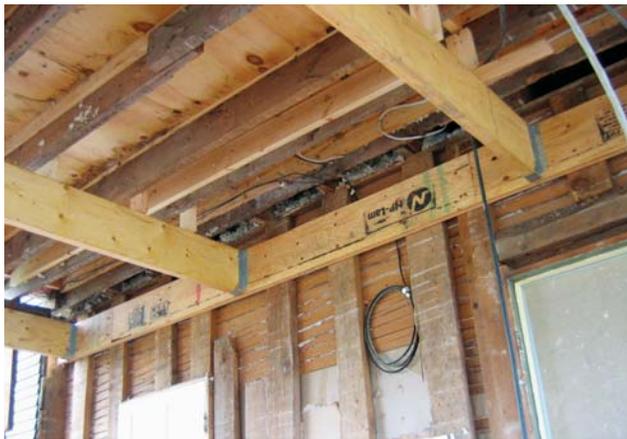
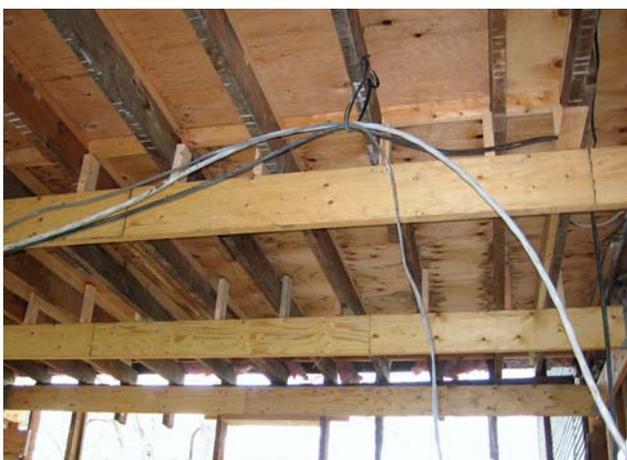
Figure 1. A new 14-inch LVL beam, inserted below the existing second-story joists, spans the 24-foot-wide kitchen ell (top). Several smaller LVLs run between the beam and a ledger attached with LedgerLok screws to the main house wall (center). Short blocks between the LVLs and the original floor joists above help to stiffen the floor system (bottom).

We located the lowest point of the sagging floor joists and snapped a line on the inside face of the exterior wall studs at that elevation. This marked the top of the LVL grid members. The first piece we installed was a 14-inch LVL beam that runs across the width of the ell about 12 feet from the gable end (**Figure 1**). This LVL was in line with the wall that would be built later between the

We next attached a 9½-inch LVL ledger to the wall of the main house, using 5-inch LedgerLok screws (fastenmaster.com, 800/518-3569), which have a structural rating of around 212 pounds per screw in an application like this. Between the ledger and the beam we hung five 18-foot-long LVLs, placing them on 6-foot centers. Two of these ran along the eaves walls and were attached to the studs with two TimberLok screws per stud. This was a critical connection: When it was time to cut away the lower part of the existing stud walls, the LVLs attached to the perimeter studs would act as headers, transferring all the overhead loads onto the steel posts.

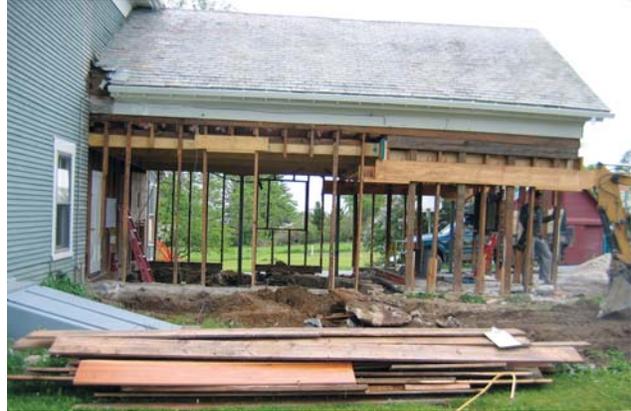
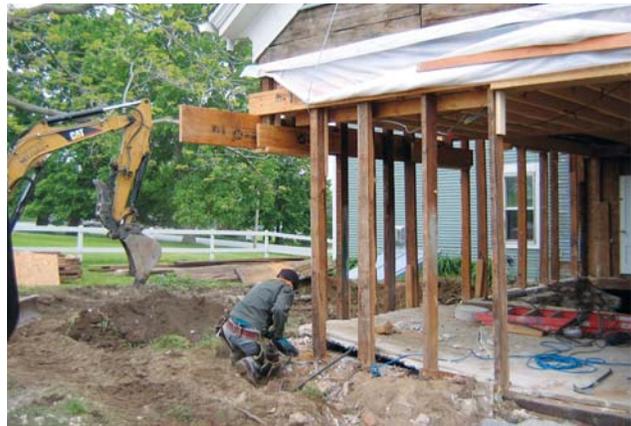
Figure 2. At the end of the ell and across the gable, wide LVLs are fastened to the outside face of the studs to pick up roof and floor loads when the walls are removed.

The gable end of the ell was framed a little differently: Here, we had no perimeter LVLs on the inside, so instead we fastened long 14-inch beams to the outside of the exposed studs, again using two or three LedgerLoks per stud (Figure 2). We ran a 9½-inch LVL across the gable end. At post locations, we added short pieces of LVL on the inside, sandwiching the studs and creating a stable bearing area for the column caps.

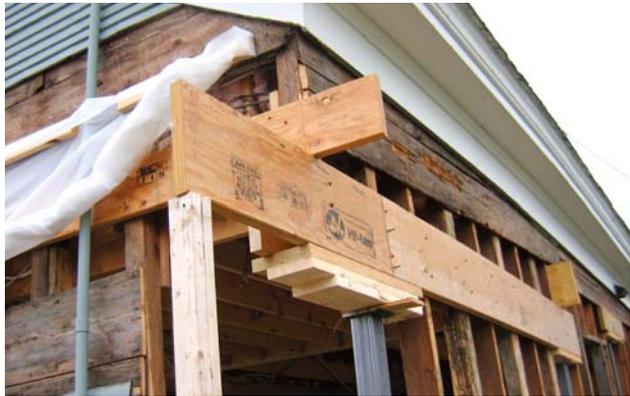
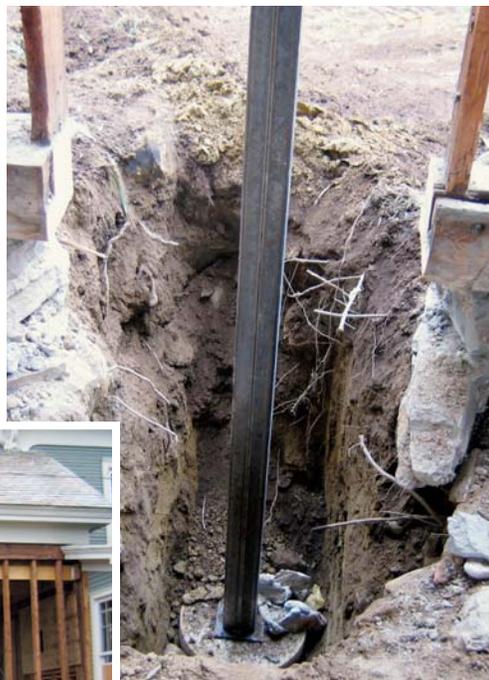
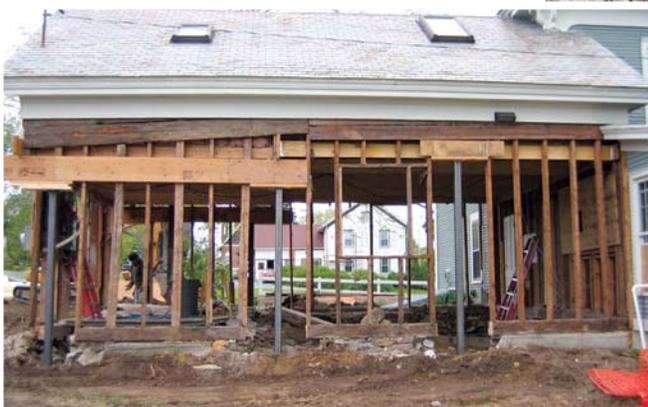
Figure 3. Working in increments around the perimeter, the crew removed as few studs as needed to excavate and install the steel posts (left). At the top, the studs were cut flush with the LVL ledgers and solid blocks inserted to provide good bearing for the 6-inch-square post caps (far left and bottom).

We used seven 4-inch-by-4-inch steel columns in all, each with a 30,000-pound capacity, to pick up the weight of the roof and second-floor framing. We worked our way from bearing point to bearing point, removing just enough studs to give us room to cut out the sill and excavate for a post footing (Figure 3, page 3). At 12 feet, the columns were long enough that we could place the 6-inch-thick, 16-inch-diameter precast concrete footings below the bottom of the eventual stem-wall footings. We placed a column under each end of the 14-inch LVL beam, one at each outside corner and the rest at intermediate locations. With the exception of the gable-end support, we placed the columns within the stud cavities so we could form and pour the footings and foundation around them.

The columns had 6-inch-by-6-inch-by-1/2-inch-thick steel plates welded to each end. As we installed each column, we used 2-by blocking and LVL cutoffs as necessary between the column's top plate and the bearing point on the LVL to ensure full support. With the steel posts in place, we removed the rest of the wall framing and the stone foundation and set about getting the old slab out of the way.

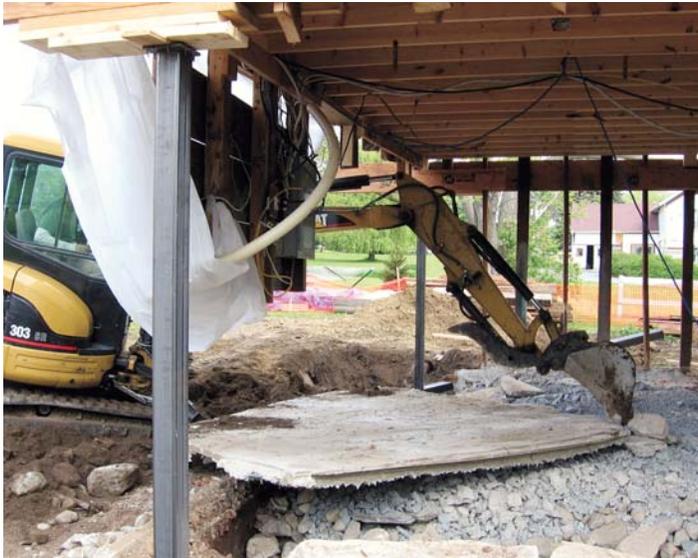
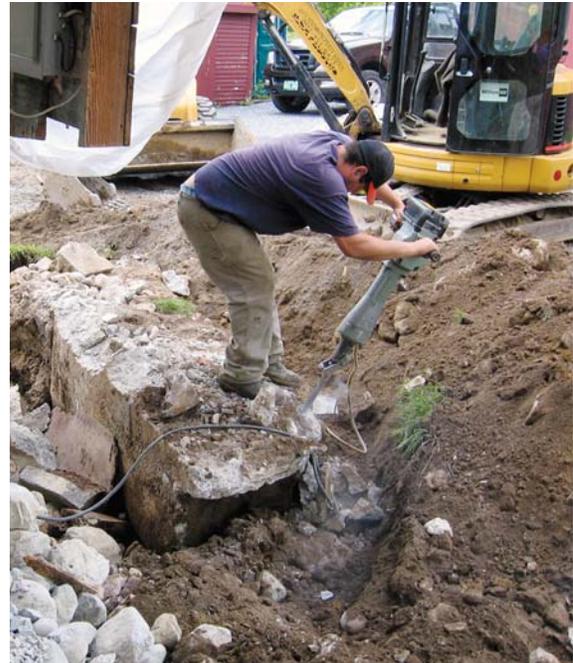
Figure 4. With the walls out of the way, the excavator carefully removes an existing concrete slab (above); part of the foundation had to be jackhammered into submission (right).

Nothing goes exactly as planned in remodeling work. We knew that there was a buried cistern just outside the existing stone foundation, and our plan was to remove it and fill in that area. Unfortunately, we soon discovered that the cistern — a stubborn structure of reinforced concrete — was attached to the main house foundation and connected to another cistern inside the crawlspace. We had no choice but to jackhammer the obstruction — an unexpected task that added about 60 percent to the budgeted excavation cost (Figure 4, page 5). The rest of the concrete was removed with the excavator.

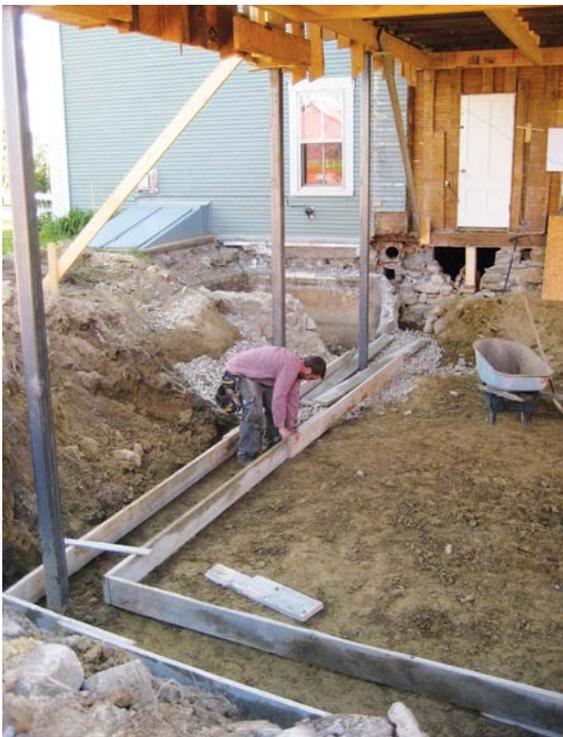
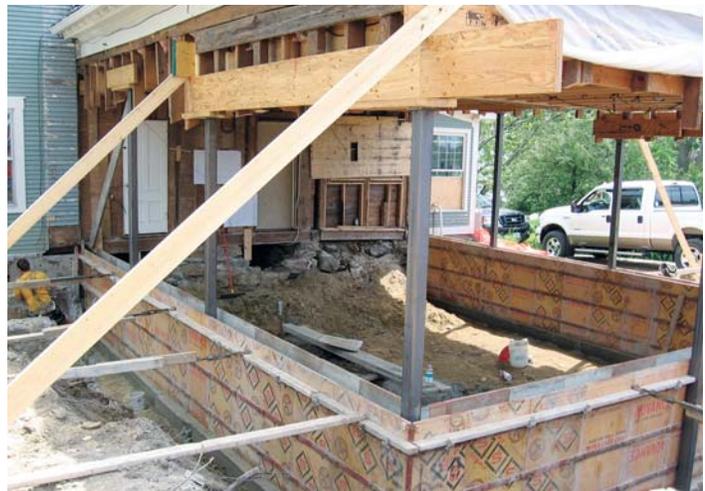
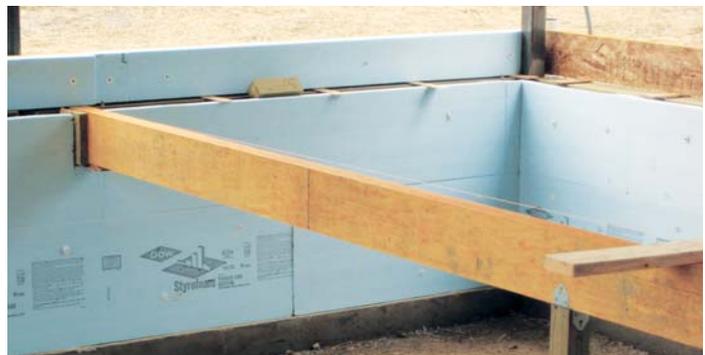
Figure 5. The new footings (above) and stem walls (above right) were formed and poured around the steel columns. The foundation and rim joist were carefully insulated with 2-inch polystyrene (right).

Once excavation was complete, we formed and poured the new foundation, working around the steel posts (Figure 5, page 5). Before framing the deck, we insulated the rim joist and the inside of the foundation wall with 2-inch-thick blueboard and covered the dirt floor of the crawlspace with a vapor barrier, which we sealed to the insulation on the walls (Figure 6, page 6). On the outside, we coated the concrete with cold asphalt, ran both a perimeter and gutter drain to daylight, and backfilled with stone.

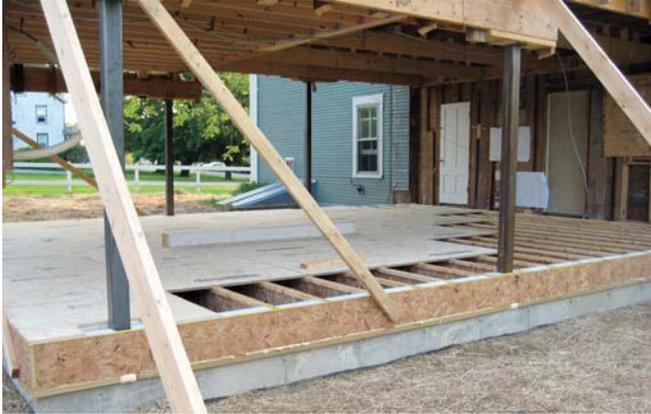
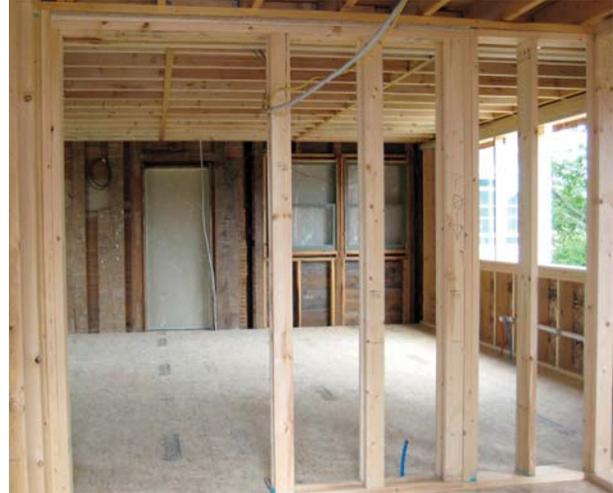
Figure 6. The posts were left in place until the deck was framed (top). As the walls were framed (top right), each steel post was cut off at the top of the rim joist. Above and right: the finished kitchen, outside and in.

At this point, we entered the phase of the project that we call “marry-up.” Working from the new deck, we proceeded to frame up the three walls needed to close the building in. First, though, we had to jack up the roof slightly to match the original benchmark elevation. We then framed the walls in place, working in short sections around each post. Once we had sufficient support, we cut each column flush with the rim joist using a reciprocating saw. (We were able to sell the remnant steel back to the fabricator, a \$700 credit on the original \$2,545 cost.)
